Test Report

PPR 526

**Performance Test
on CRSM heat-shrinkable
Wraparound Repair System**

Report on testing Raychem-Wraparound repair system

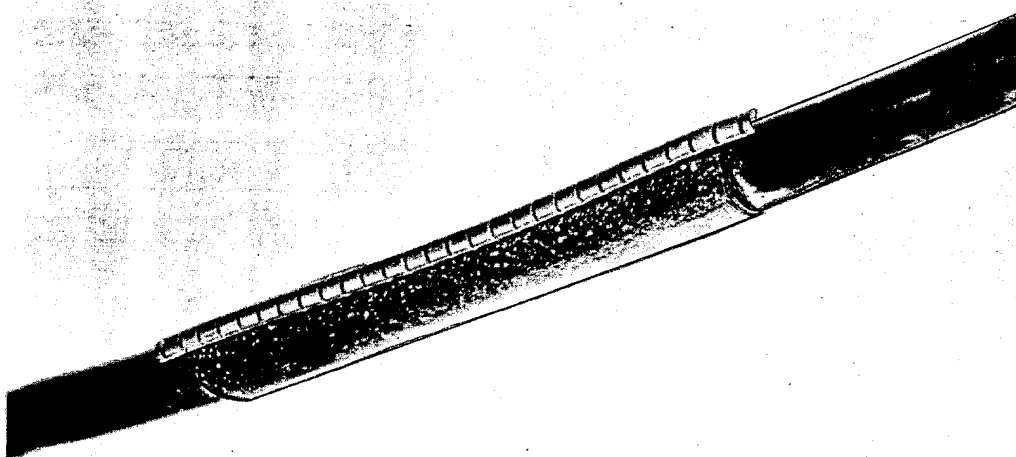
Picture 1 One sample

Samples Number: 3
Type CRSM (formally WRSM)
Cable NAYCWY 3 x 95 se/95 0.6/1 kV
(Plastic insulated). The cable jacket has been removed in the test area. The sleeve overlapped the cable jacket on both sides for approx. 50 mm.

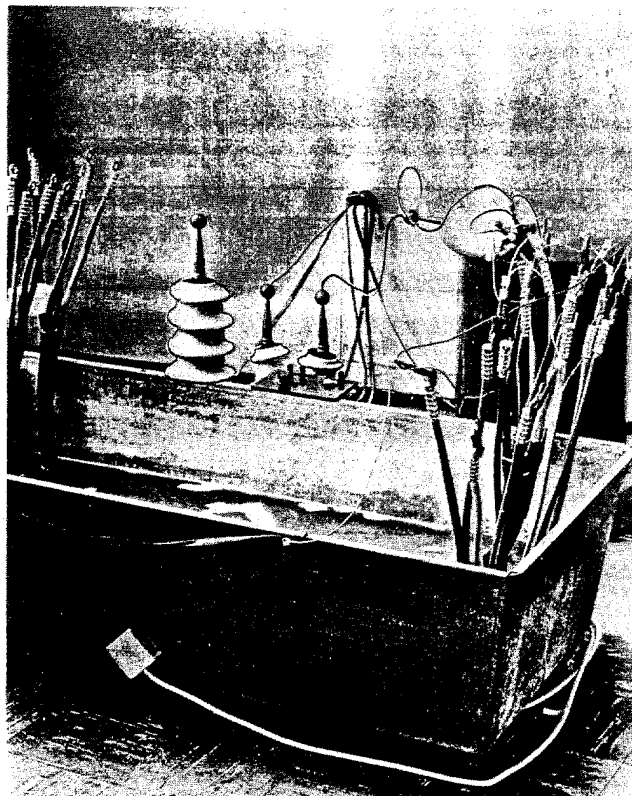
Picture 2 A.c.-voltage test

2. A.c.-voltage test (see pict. 2)

Test in accordance with VDE 0271/3.69 Par. 19 "Specifications for PVC insulated cables in power installations". After removing the samples from the water bath after testing in accordance with test 1., a sinusoidal test voltage of 2.8 kV (50 Hz) was applied between 2 cores in turn, while the other 2 cores and the water container were earthed. The test was carried out by applying the test voltage to each core for 30 minutes.

Result No breakdown or flashover with any of the samples.

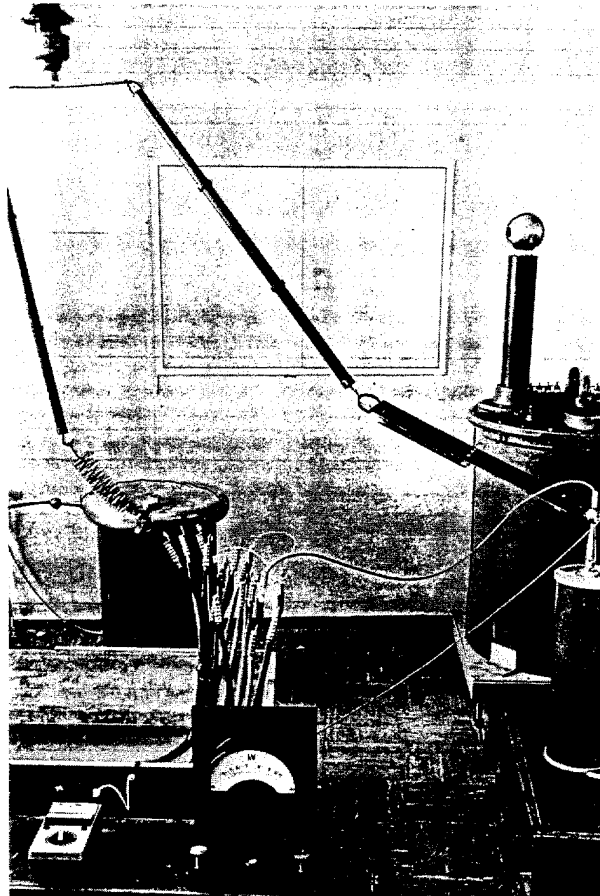
Picture 3 Leakage current test

3. Apply d.c.-voltage and measure leakage current (see pict.3).
The leakage current between the insulated container and ground was measured by applying a d.c.-voltage of 6 kV for 15 minutes to the cores connected together.

Result Leakage current with all specimens $< 0.1 \mu\text{A}$.
